Retrofitting and refurbishment processes of heritage buildings: application to three case studies

Dissertação de Mestrado Integrado em Engenharia da Energia e do Ambiente

2014

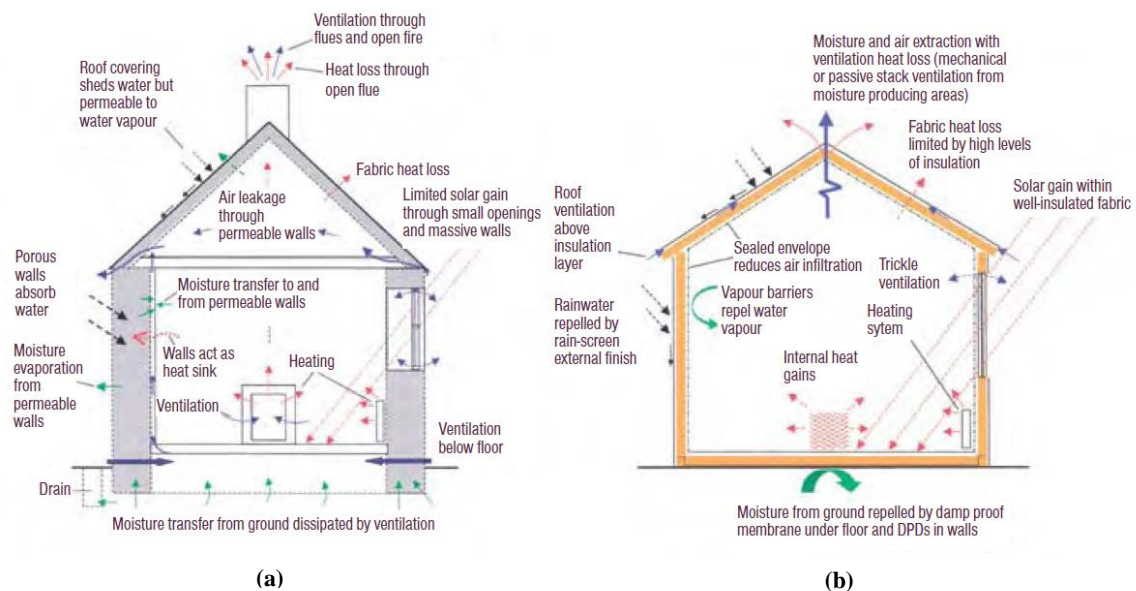
Figure 2 shows moisture, air movement and thermal performance of a historic building (a) and a modern building (b). Historic buildings present more sources of heat transfer through porous and permeable walls, ventilation through open flue and open fire and also from below floor. There are heat losses due to fabric characteristics and limited solar gain caused by small openings and massive walls. Modern buildings show a sealed envelope which reduces air infiltration and moisture from ground, creates vapour barriers and limits heat loss. Additionally solar gain increases within well-insulated fabric. Over-sealing historic buildings can cause considerable problems in terms of condensation and other associated problems. In addition, in rooms where there is a gas or solid fuel burning appliance, it is crucial to have adequate ventilation as a safety requirement (Change Works, 2008).

Figure 2 - Historic (a) and modern (b) buildings functioning (source: Change Works, 2008)

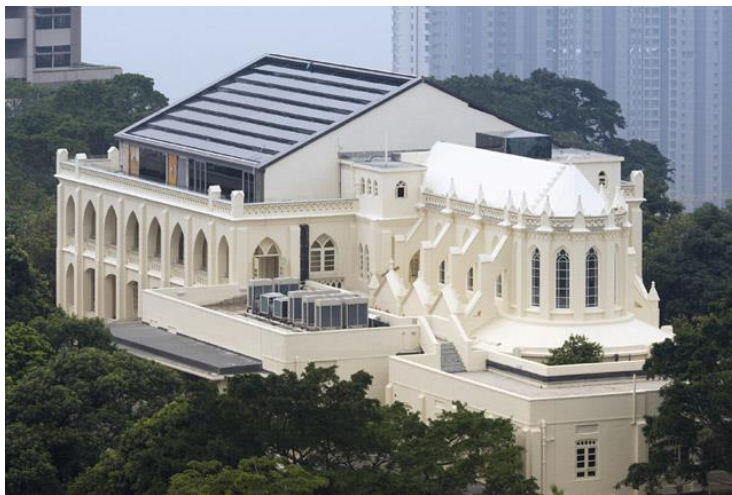
Figure 3 - Bethanie Chapel adapted to an Academy for performing arts in Hong Kong (source: Yung & Chan, 2012)

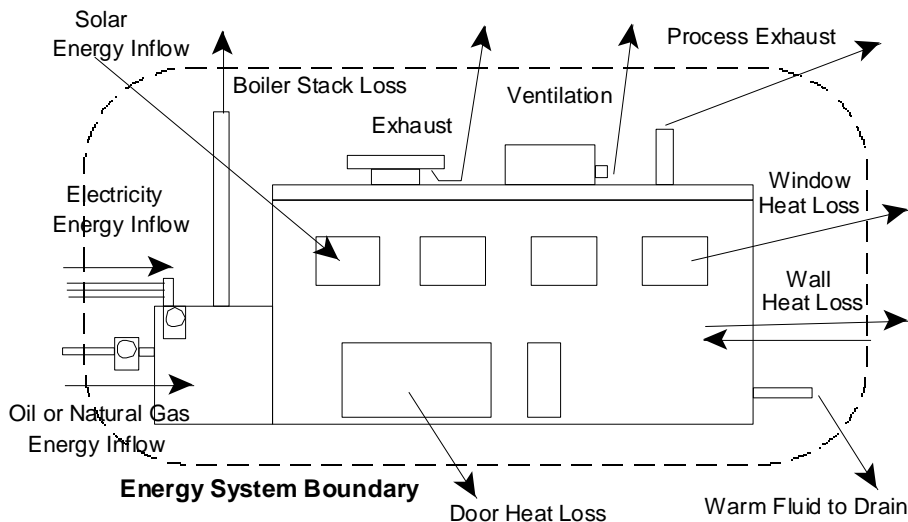
Energy auditing assumes a simple energy balance within a building: what comes in equals what goes out (CIPEC, 2011). Figure 6 illustrates this mathematical expression. Energy can leave through a certain area, resulting in energy losses for the building (heat loss, exhaustion, ventilation). As a consequence, energy balances can only be prepared for restricted areas with boundaries defined. The envelope of a building is what defines the boundaries.

Figure 6 - Energy transfer in a system (source: CIPEC, 2011)

The amount of air leakage through the building envelope or air permeability can be measured using a fan pressurisation method such as the blower door test (BSI, 2001). Also smoke generators can be used to identify areas of leakage in the building or portable smoke pencil to identify leakage in specific locations. The maximum allowable infiltration or air permeability of a building is defined in various standards. Performing this technique will provide data relatively to the process of exhaustion and ventilation that Figure 6 shows.

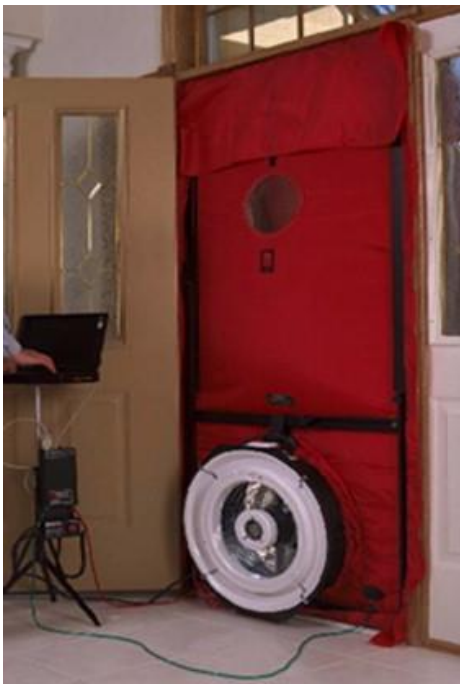
Blower doors are still used to find and fix the leaks but the values generated by the measurements are more often used to estimate infiltration for both indoor air quality and energy consumption estimations. These estimations are used for comparison to standards or to provide program or policy decisions (Kreith & West, 1997). The construction quality of the building envelope plays an important part having to assure that the envelope is tight enough so leakage does not affect energy, comfort or airflow. Hence, the construction quality of the building envelope plays an important part having to assure that the envelope is tight enough so leakage does not affect energy, comfort or airflow. Blower Door data estimates airflows at a variety of pressures and mostly at a 50 Pa pressure difference (Sfakianaki et al., 2007). In case of buildings with many leaks and particularly large buildings, the airtightness measurement should be performed at 25 Pa instead of 50 Pa (Pfluger & Baldracchi, 2011). The advantage of this method is that their results are less affected by climatic conditions. During the measurements a fan is used to supply or exhaust air from dwellings at rates required to maintain a specified pressure difference across the building envelope, as shown in Figure 7.

Figure 7 - Set-up equipment of a blower door for the measurement of air tightness (source: Chen et al., 2012)

The air flow and the pressure difference are measured once and again; after the test conditions are stabilized, the measurements are recorded (Chen et al., 2012).

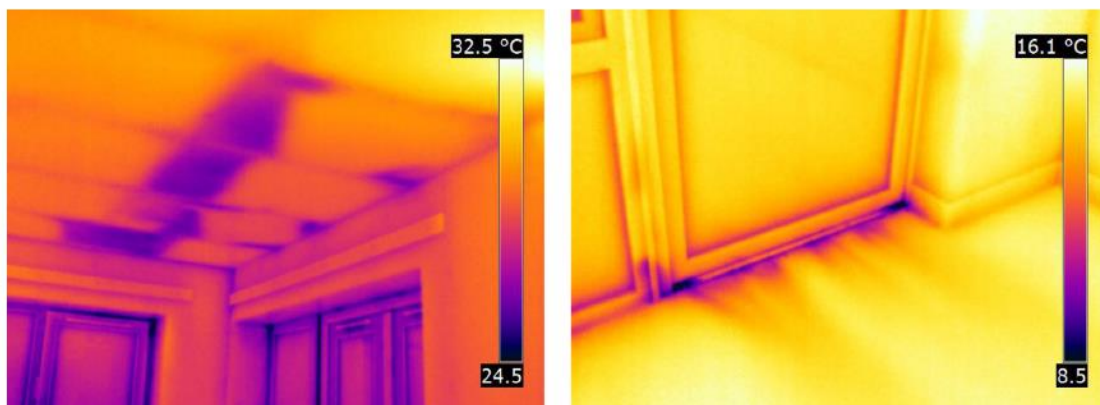
In addition to identifying insulation defects and thermal bridges, thermography is also used to locate air leakage paths in the building envelope. Air leakage can be observed internally when the building is depressurised (e.g. during an air leakage test) provided there is a difference between internal and external air temperatures. Figure 8 shows the appearance of some typical insulation and air leakage defects.

Figure 8 – Construction flaws identified using thermography: on the left) an area of ceiling where insulation above was installed incorrectly; on the right) air leakage below a door cools the surface of the surrounding floor. (source: Taylor et al., 2013)

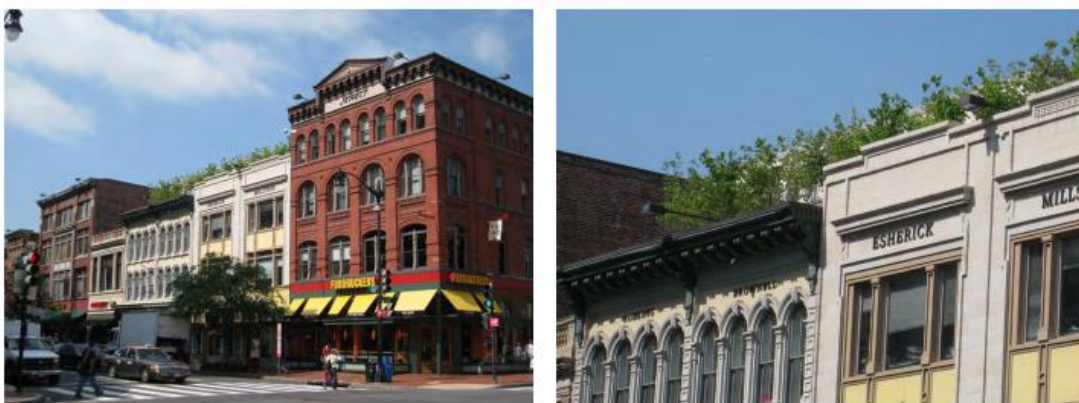
Figure 11 - Incompatible solution: the plantings were highly visible above the parapet wall (source: Petrella, 2009).

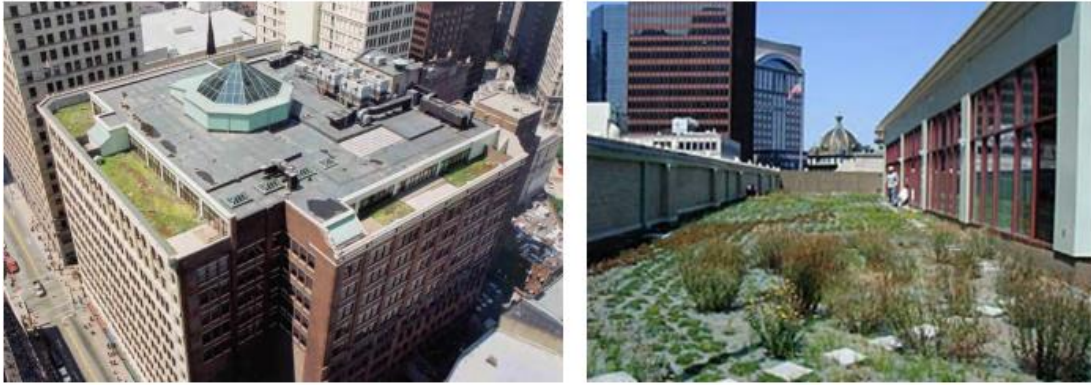
Figure 12 - Compatible solution: the tall parapet wall prevents the viewing of the green roof sections from the street below (source: Petrella, 2009).

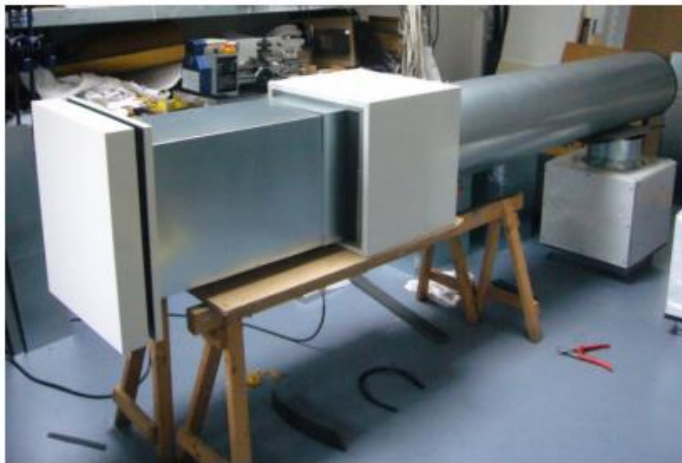
Pfluger & Baldracchi (2011) overviewed possibilities of integration of a heat exchanger in the building structure such as integration in walls and ceilings. In most cases the systems are not really integrated into the structure of the building. Nevertheless, an active overflow prototype (Figure 14) was constructed and tested in a heritage building working as a school. The idea is to vent fresh air into the corridor and staircase with fans actively pushing the air from the corridor into the classrooms. Typically, to optimize this approach the ventilation system is linked to a heat recovery and therefore ducts for air inlet and exhaust to and from the rooms. Silencers are also needed to prevent noise. The prototype aims at avoiding the need for ducts in the corridor or for the installation of a vertical shaft to provide fresh air. The heat recovery system is instead placed on the attic and the fresh air is distributed via the open staircase and corridors through vertical ducts. For protected buildings, this is an advantage compared to decentralised systems with two openings per room (in and outflow) to the outside (impacting on the building structure). Hence this solution should only be applied for heritage buildings (Rambelli et al., 2013).

Figure 14 - Prototype of active overflow system (source: Rambelli et al., 2013)

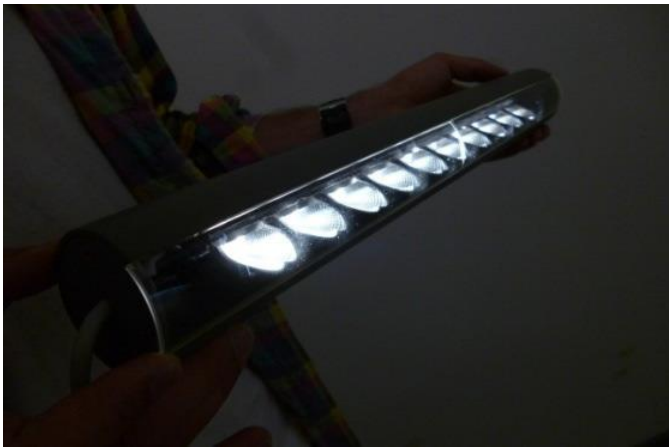
Interventions as additions in the wall and ceiling structures are limited in heritage buildings. Therefore, according to Pfluger & Baldracchi (2011) artificial lighting installation is defined to be a difficult requirement which can be fulfilled by stand-alone-solutions such as floor lamps. It is also recognised that currently there are not many luminaires available on the market aligned for the lighting of historic buildings. In general it can be said that the artificial lighting in historic buildings is much reduced. As solutions, consistent with the needs of conservation of spaces, efficiency and energy savings, LED technology is ideal for buildings in which invasive refurbishment is not an option. The use of LEDs allows the luminaire to reproduce the illumination given by incandescent lighting: 2700K (Weitlaner, 2013). An illumination concept was developed, that is able to fulfil the human and material requirements (Rambelli et al., 2013). Figure 15 shows the luminaire “wallwasher”, which can be installed in a non-invasive way. It provides on one hand optimized visual scenery and on the other hand it should slow down the deterioration process that any material undergoes in its natural (or artificial) environment.

Figure 15 - Prototype of luminaire (source : Rambelli et al., 2013)

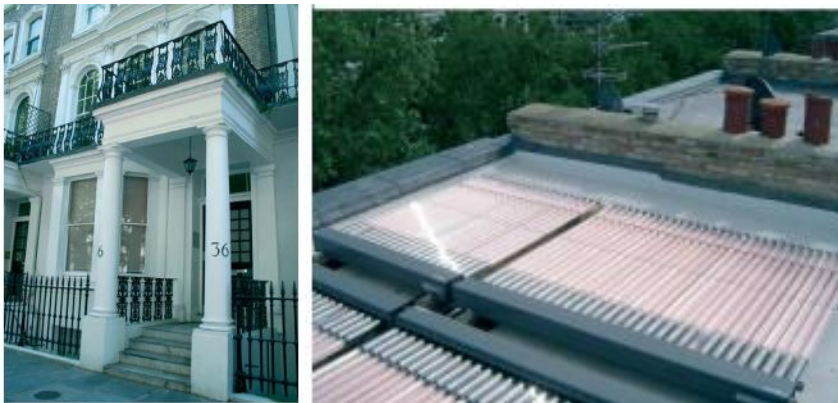
In the UK, there is a terraced house from the 19th century, which flat roof allows a collector to be hidden from ground level. Figure 16 shows the horizontally mounted collector having the least visual impact behind the parapet wall. If it is not acceptable to fix collectors to the roof, or it is not physically possible to accommodate them one alternative is to position them elsewhere – on another building, for example – with the pipes buried and routed back to the storage tank (English Heritage, 2008). Where land is abundant the collector may be mounted on the ground. An example of such a free-standing installation is in a vacancy cottage, also in the UK. The collector is mounted in the garden and surrounded by a fence, with hot water piped back to the cottage (English Heritage, 2008).

Figure 16 - Evacuated-tube solar collector on a flat roof of a 19th century house (source: English Heritage, 2008)

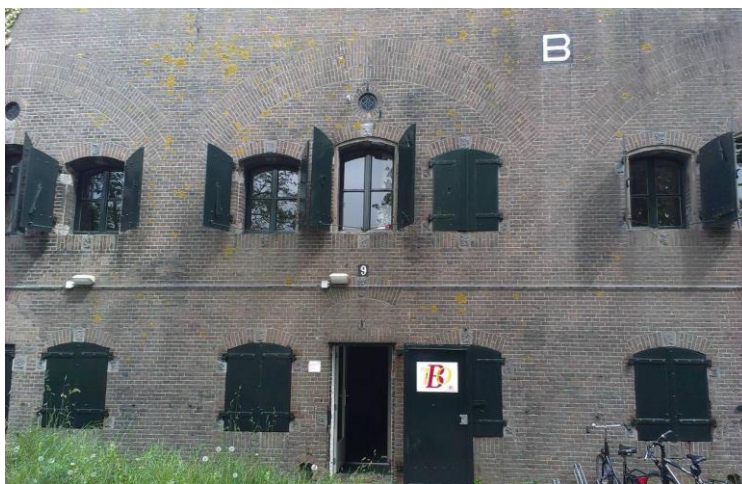
Since 1971, Fort de Gagel is governed by the policy principles of the municipality of Utrecht, the provincial government of Utrecht and the central government. On one hand, these entities aim at preserving the cultural-historical, monumental, civil engineering and military-historical assets of fortresses. On the other hand, it is also intended to enhance the landscape and wildlife value achieving sustainable development. Only minor renovations such as wooden floor restoration to its original design and heating systems installation took place in the periods 1960/70 and 2000/2010. Figure 20 shows the current state of the fortress.

Figure 20 - Fort de Gagel (source: Tersteeg, 2014)

surrounded by a moat. Starting from 1848 the fortress has been substantially amended. Between 1850 and 1852 on the city side the defensive structure was built (bomb-proof guardhouse), with walls of 1500 mm thick masonry. The ground floor is of stone and partly of wooden beams with wooden floors. The first floor is entirely made of wooden beams with wooden floors. Fort de Gagel has single glazed windows that are set back 400 mm from interior shutters. The roofs are integrated in defensive wall, i.e. covered by earth and vegetation. About 1880, the fort was again improved (rebuilt at the inner site). The moat around the guardhouse was partially muted, after which the bomb-proof barracks and depot were built. In the first half of the 20th century the wall was partially excavated. In the years 1935-1940 three group shelters of reinforced concrete were built on the outer slopes. After World War II, Fort de Gagel was used for the last time for military purposes and the trenches situated between the group shelters were muted. Additionally, the entries of the Group shelters are closed with brickwork. The guardhouse is now entirely in the condition of 1880 and to all sides with shoot-holes oriented on the Gagel dyke. Nowadays, the barracks function as offices and are of 1000 mm thick. Offices are located on the first floor of the southwest facade allowing natural lighting. Appliances in use include computers, printers and other office appliances related to standard office use. Regarding the heating system, the barrack building has newly installed radiators and central heating system consisting of a heating boiler and water (electrical) boiler.

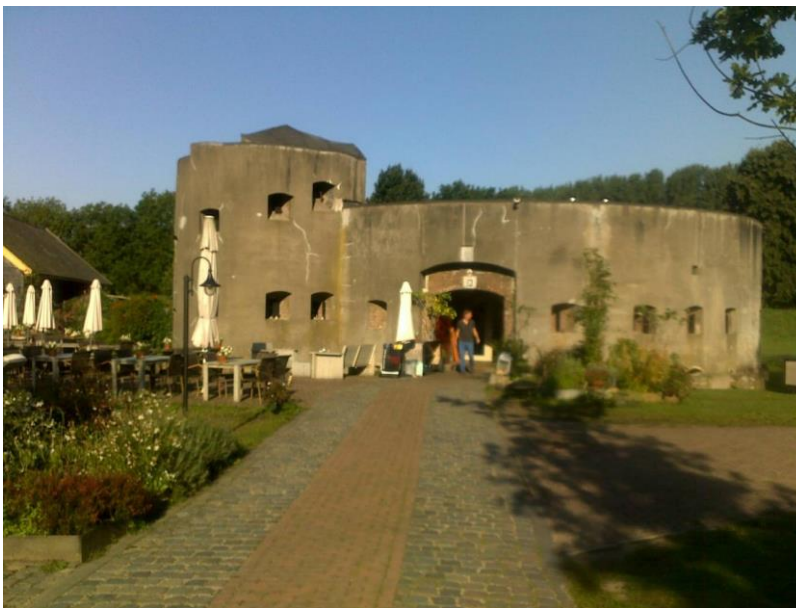
The construction of Fort aan de Klop began in 1819. The guardhouse was built between 1850 and 1852. Redesigning occurred twice: in 1900 and in 1913. The whole fortress was renovated in 2007. Figure 21 shows the current exterior aspect of the fortress. The guardhouse represents the defensive structure with 1500 mm of thick masonry. It has single glazed windows, solid floors and flat roof, housing a restaurant and a kitchen. In the guardhouse windows are set back 400 mm so the walls work as shading devices. Besides the guardhouse there are barracks consisting in group accommodation and other buildings. These barracks were renovated between 2005 and 2007 consisting of wooden insulated walls, equipped with general double glazed glass and exterior window shutters of historic design. The lighting system consists of halogen and low energy light bulbs and the appliances in use are reported as standard restaurant appliances (M. Bonnike, personal communication, October, 2014). The guardhouse is heated by radiators (being a gas boiler the source) while some of the barracks are heated through floor heating. Other measures already implemented include: i) water saving shower heads; ii) modern toilets with dual flush; and iii) a small kitchen garden with some herbs.

Figure 21 - Fort aan de Klop (source: Janssen, 2012)

The purpose of the renovation in 2007 was to build a restaurant in the old guardhouse while renovating the exterior and interior of the guardhouse. Furthermore, the bat habitat in the basement was created and preserved. The purpose of renovating de Fort aan de Klop within this project is to create an energy efficient and sustainable building while making the fortress even more attractive for visitors.

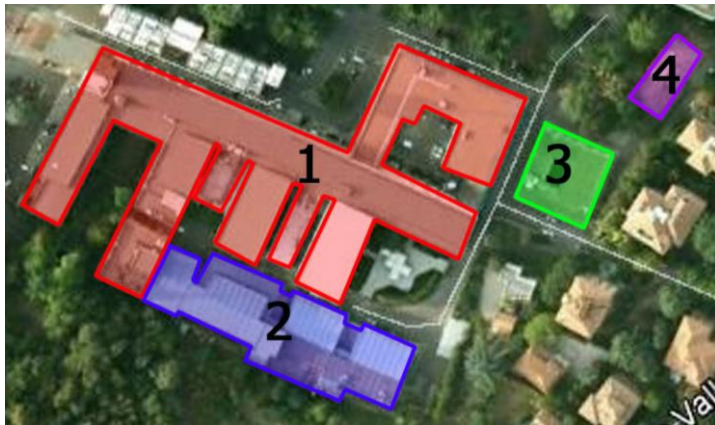
heritage buildings obey to strict laws from different entities when renovations are being considered. However its energy management is difficult due to different functions and rooms in a broad range of sizes (Garai et al., 2014). The School of Engineering and Architecture of Bologna is composed by 4 building as Figure 22 shows:

- Building 1⁷: the historical main building of the Faculty of Engineering built in 1935.
- Building 2: Building built later in the 1980's.
- Building 3: Building built in the 1980's.
- Building 4: Building built after 1935 having the same building materials of building 1.

Figure 22 - The buildings composing the School of Engineering and Architecture of Bologna (source: Garai et al., 2014)

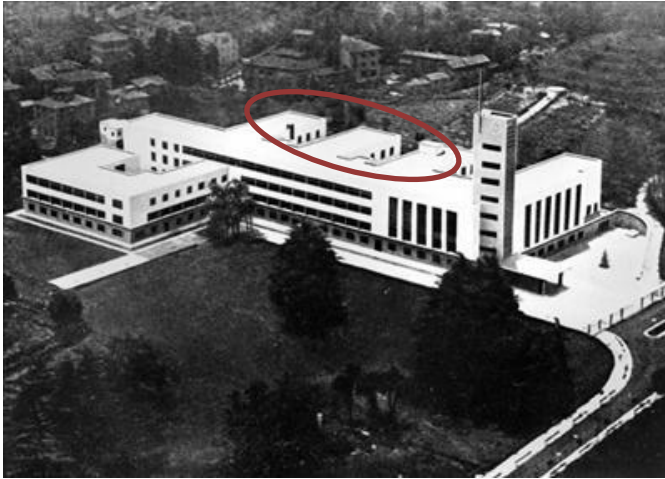
Figure 23 - Building 1: the historical main building of the Faculty of Engineering (source: Garai et al., 2014). The drawing classrooms are encircled.

The gas heating plant is in the basement, in a central position with respect to the heated volume and with natural circulation. The heating layout consists of: central system with three gas boiler, a heating boiler and a heat pump. The distribution system is made of non-insulated pipes placed in the walls, the vertical pipes connecting the radiator positioned at the various levels.

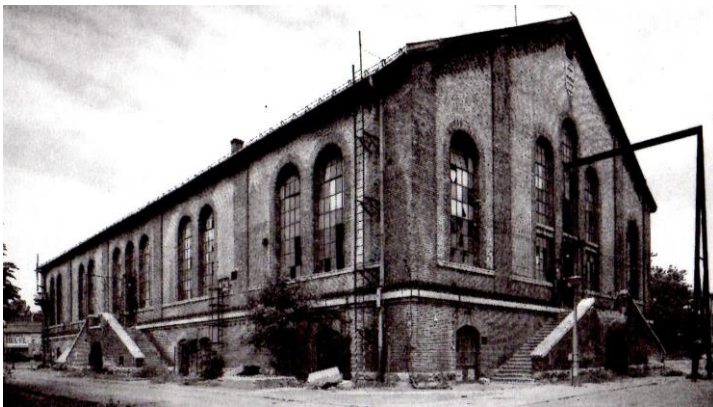
buildings and housing estate. The “Meter House” was the selected building to be refurbished and or/ retrofitted. The “Meter House” was built in 1914 and is one of the most valuable buildings of the factory complex in terms of heritage aspects (Figure 24). It was used for measuring different gases. It has a symmetrical, long rectangular and solid floor plan, dual-pitched roof and red and yellow brickwork facade, without shading. The facades are divided into sections with groups of two or three slender, vaulted single windows between them. The existing external walls are made of small-size clay bricks of varying thickness with plaster finish on the inner side. The interior of the ground floor constitutes a continuous space with open steel roof structure. The “Meter House” currently functions as storage site for stones, using no energy. Establishing a Contemporary Cultural and Communication Centre, suitable for large masses and perform various functions is the aim of the refurbishment process. Through this form of utilization, the building will be accessible to a wider audience and its operation will become also more efficient.

Figure 24 - The “Meter House” (source: Alexa et al., 2014)

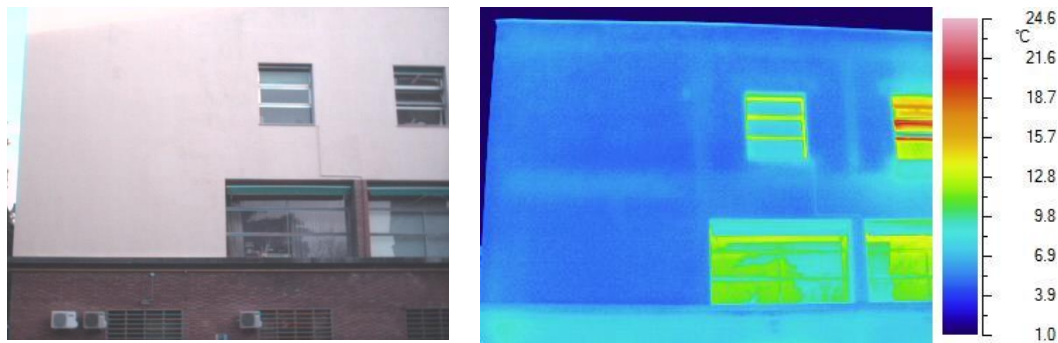
Figure 25 shows a photo of the facade of the Faculty of Engineering on the left and an infrared photo of the same façade taken with an infrared camera on the right. The infrared highlights the thermal bridges and the different insulation of the building. In the figure thermal bridges are detectable through different colours: red is the warmer and blue is the colder. The higher the temperature, the faster the heat loss. By observing the infrared picture it was noted that the temperature is higher in the reinforced concrete frame than it is in the walls. Also, the frames of the windows revealed to be warmer than the walls. Better insulation of the frames could help to improve the storage of heat inside thus better thermal and energy performance.

Figure 25 – Thermography of building 1. On the left: the façade, on the right: thermal bridges on the façade can be found (source: Garai et al., 2014)

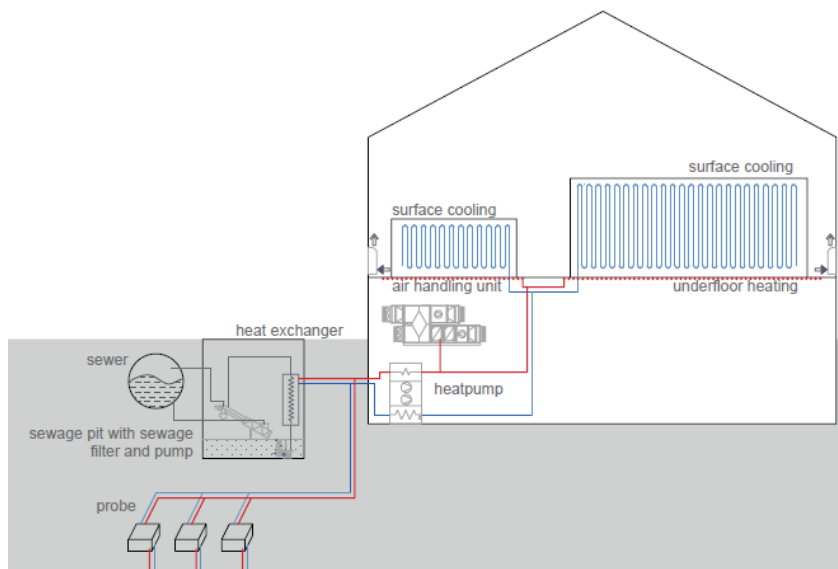
On the topic of energy systems, it is planned that gas will not be used after refurbishment and implementation of previous measures. If the “Meter House” functions as Contemporary Cultural and Communication Centre, then heat recovery from wastewater is a cheap energy source available in urban areas and production facilities. Figure 26 shows the envisioned wastewater heat recovery system. The system works by extracting the heat from the shower or bath water sent down the sewer. The temperature of communal wastewater falls in the range between 10°C and 20°C, while industrial wastewater can be warmer than that. Therefore, the wastewater is stored in closed pipe loops buried in the ground. The wastewater heats the circulating fluid of the heating system in the heat exchanger. In the heat pump, through phase changes, the circulate fluid is heated/cooled depending on the thermal needs of the building. The heat from the wastewater is harnessed to underfloor heating or surface cooling. The location of the gasworks is also an advantage: wastewater collecting ducts are under the main road at a distance of hundred meters. Due to its virtually constant temperature, wastewater heat offers much better energy efficiency than soil heat or groundwater. Part of the cooling energy needs during the winter is covered by free cooling. Free cooling is the method of storing outdoors coolness during the night, and supply to indoor air during the day. Main advantages are cooling with reduction of greenhouse gases and indoor air quality maintenance inside the building (Raj & Velraj, 2010). The other part of the cooling energy is provided by heat recovery by high temperature of exhausted air (efficiency higher than 80%). Therefore, the energy need of the HVAC system would be reduced due to the architectural design and the heat recovery.

Figure 26 - The envisioned wastewater heat recovery system (source: Alexa et al., 2014)

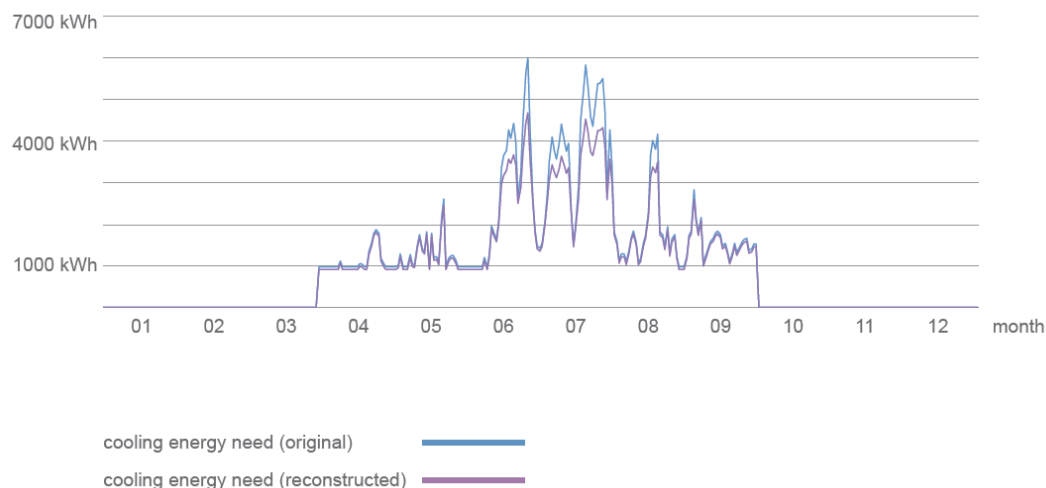
Figure 27 - Example of an energy profile (source: Alexa et al., 2014)
